Manhole Inspection Summary

Manhole # S55U__009MH

Insp Date: **2/6/09 8:16 AM**

Location Address: **1800 CLINTON ST**

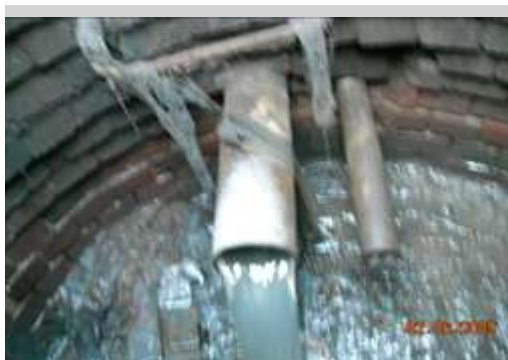
MISC.\

2 INCH PVC PIPE INTRUSION @ 9 OCLOCK; DETERIORATION AROUND PIPE SEAL; 2.75ft ROD & BAR

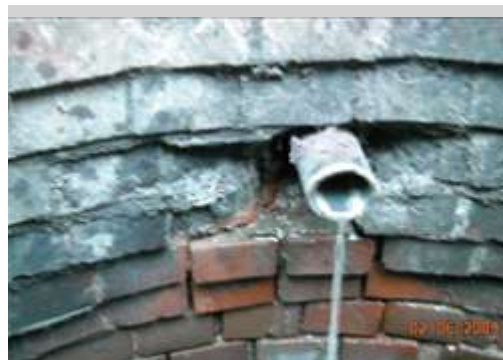
MISC.

2 INCH PVC PIPE INTRUSION ABOVE 6 OCLOCK; 2.24ft ROD AND BAR

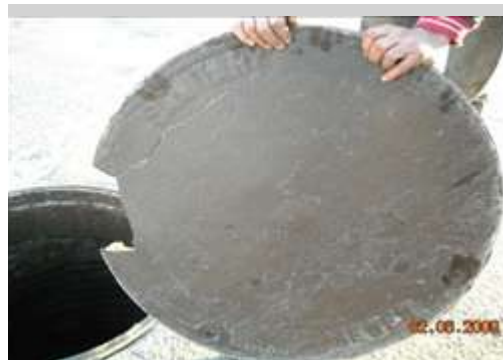
MISC.

BROKE COVER TO GAIN ACCESS

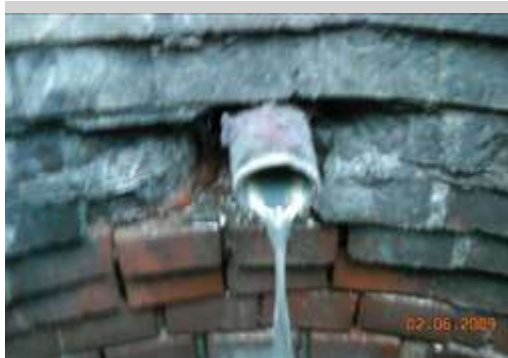
Defect 8

Condition: ☐ Sound ☐ Cracked ☐ Root Intrusion ☐ Loose Brick ☒ Deteriorated

DETERIORATED BARREL BRICKS
FROM PIPE INTRUSION

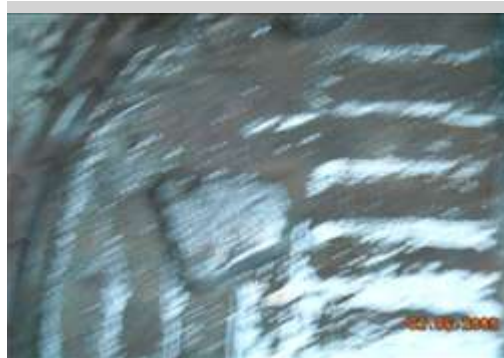
Defect 7

Condition: ☐ Sound ☐ Cracked ☐ Root Intrusion ☐ Deteriorated ☐ Leaks ☒ Debris

DEBRIS ON BENCH

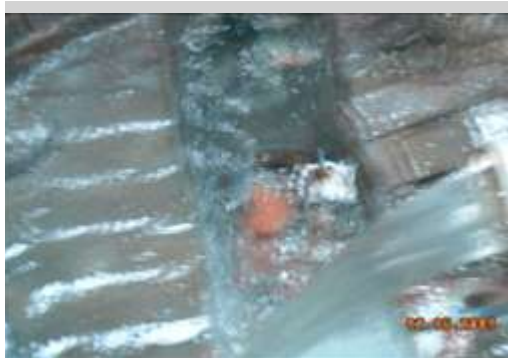
Defect 6

Condition: ☐ Sound ☐ Cracked ☐ Root Intrusion ☐ Deteriorated ☐ Leaks ☒ Debris

DEBRIS IN CHANNEL

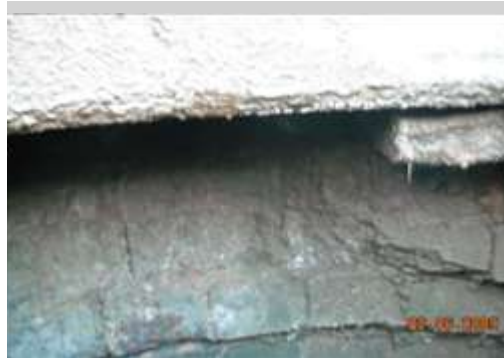
Defect 5

Condition: ☐ Sound ☐ Cracked ☐ Root Intrusion ☐ Loose Brick ☒ Deteriorated

DETERIORATED CORBEL BRICKS

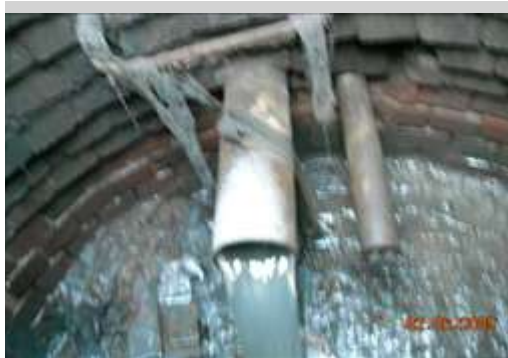
Defect 4

Surcharge ☒ Evidence Of Surcharge Depth: **4** (ft.) ☐ Active Surcharge Present

EVIDENCE OF SURCHARGE

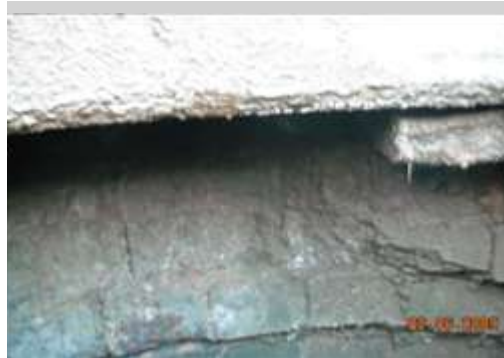
Defect 3

Condition: ☐ Sound ☐ Cracked ☐ Root Intrusion ☒ Loose Brick ☒ Deteriorated

DETERIORATED CHIMNEY

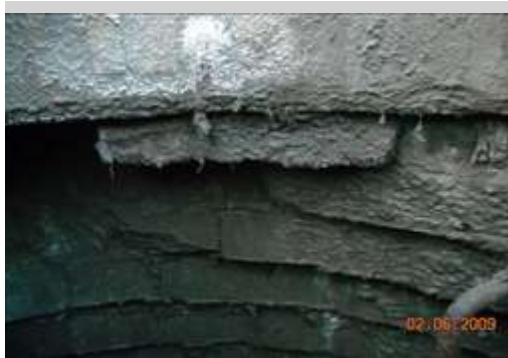
Defect 2

LOOSE CHIMNEY BRICK

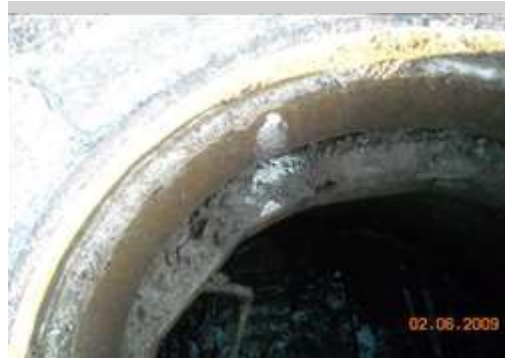
Defect 1

Frame Offset: **3** (in.) Condition: ☒ Sound ☐ Cracked ☐ Leaks

FRAME OFFSET

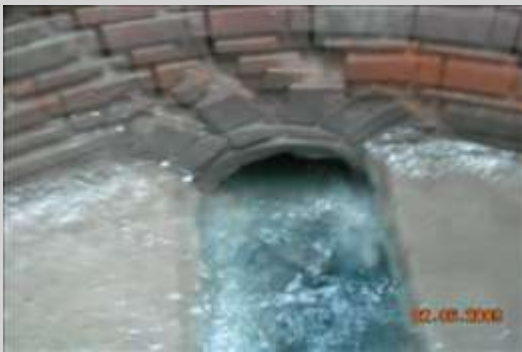
12 O'Clock Outflow

8 in. Circular Gravity Sewer
Pipe Out @ 12 O'Clock

Pipe Height: **8.4** (in.) Rod and Bar (Angled)
Pipe Material: **Clay** ☐ Pipe Lined
Invert Depth: **5.60** (ft.) Flow Characteristics: **Slow**
Deposits: ☐ None ☐ Mud ☐ Sludge ☒ **Debris** ☐ Grease
Silt Depth: **3** (in.) Deposits Extent: **Medium**
Infiltration: **None** Pipe Seal Cond: **Broken**

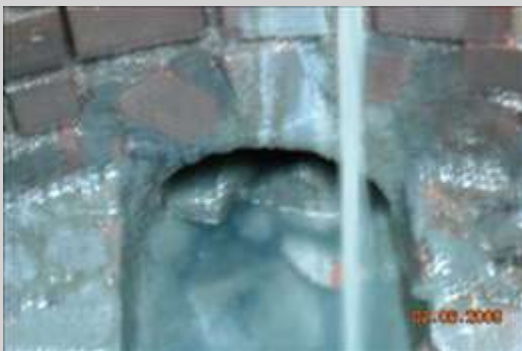
6 O'Clock Inflow

8 in. Circular Gravity Sewer
Pipe In @ 6 O'Clock

Pipe Height: **8.4** (in.) Rod and Bar (Angled)
Pipe Material: **Clay** ☐ Pipe Lined
Invert Depth: **5.40** (ft.) Flow Characteristics: **Slow**
Deposits: ☐ None ☐ Mud ☐ Sludge ☒ **Debris** ☐ Grease
Silt Depth: **3** (in.) Deposits Extent: **Medium**
Infiltration: **Evidence** Pipe Seal Cond: **Sound**

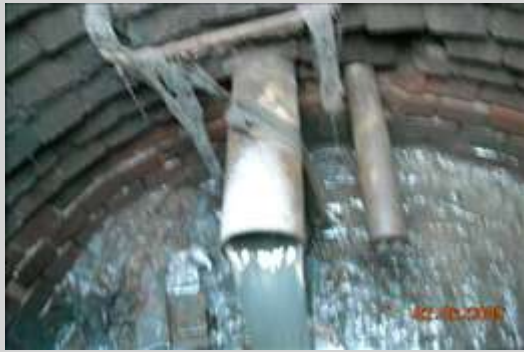
9 O'Clock Inflow

4 in. Circular Gravity Sewer
Pipe In @ 9 O'Clock

Pipe Seal Cond: **Broken**

☒ **Possible Illicit Connection**
